PHASE I INSPECTION REPORT
NATIONAL DAM SAFETY PROGRAM

UPPER VALLE MINES DAM
Jefferson County, Missouri
Missouri Inventory No. 30370

Phase I Inspection Report
National Dam Safety Program

Name of Dam	Upper Valle Mines Dam
State Located	Missouri
County Located	Jefferson
Stream	Unnamed Tributary of Joachim Creek
Date of Inspection	15 August 1980

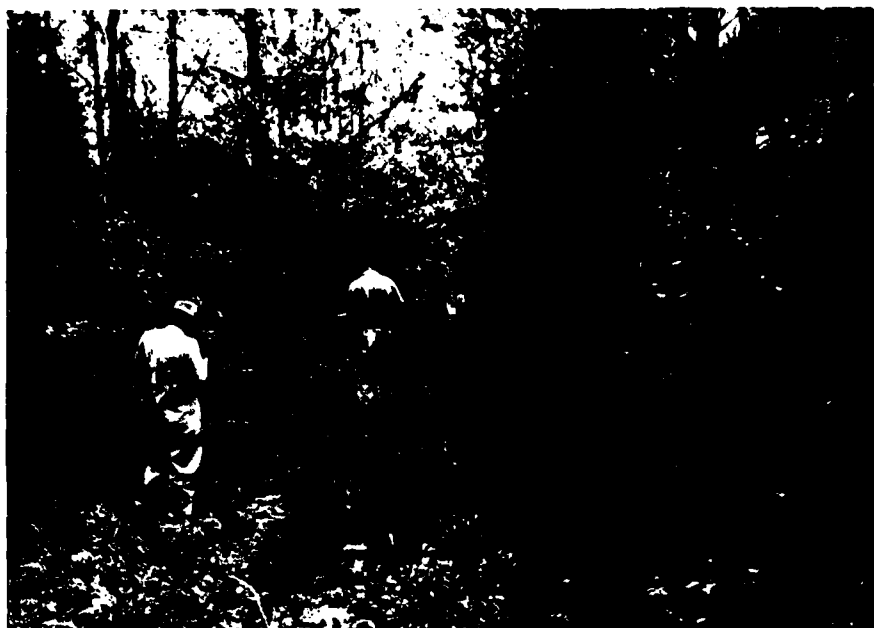
1. View along crest of dam. Note dense vegetation on upstream face (right) and downstream face (left). Looking east.

2. Removal of large trees and control of detrimental vegetation on the embankment. This study should also include methods of controlling vegetation in the spillway and discharge channel. Removal of large trees should be done under the guidance of an engineer experienced in the design and construction of dams. Indiscriminate clearing may jeopardize the safety of the dam.

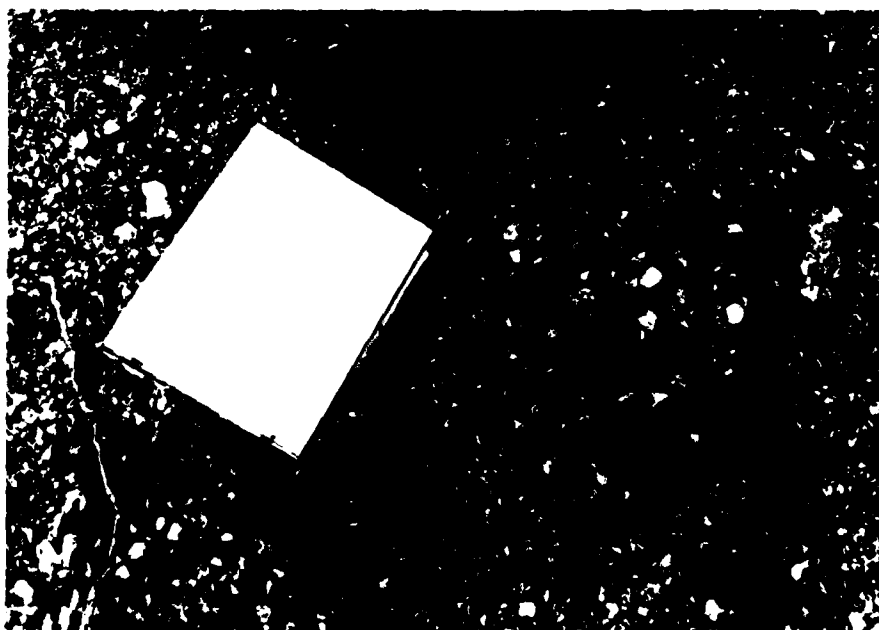
Minor gully erosion was noted on the exposed portion of the downstream face. The dense vegetation probably offers some erosion protection. The chat mantle, exposed at the east end of the embankment, is judged to be highly erodible for flow velocities of 5.0 ft/sec or greater, such as that created on the steep downstream face during potential overtopping (Photo 4).

4. Exposed chat, gravel-sized tailings; near east end of embankment.

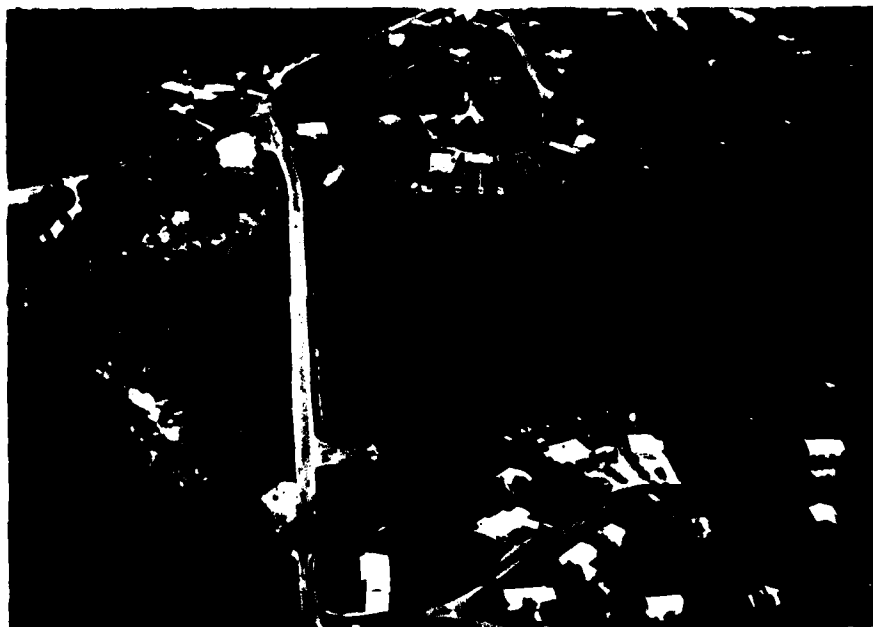
The amount and duration of total outflow for this dam will jeopardize the safety of the downstream residents and dams. The total outflow from this dam is likely to inundate some downstream structures as shown in Photos 9, 10 and 11. The severity of inundation and damage is unknown without further studies.

11. Valle Lake Dam approximately two miles below
Upper Valle Mines Dam, within downstream
hazard zone. Looking east.
